NADA vehicles - Keeping Them Alive by Dixon Kenner

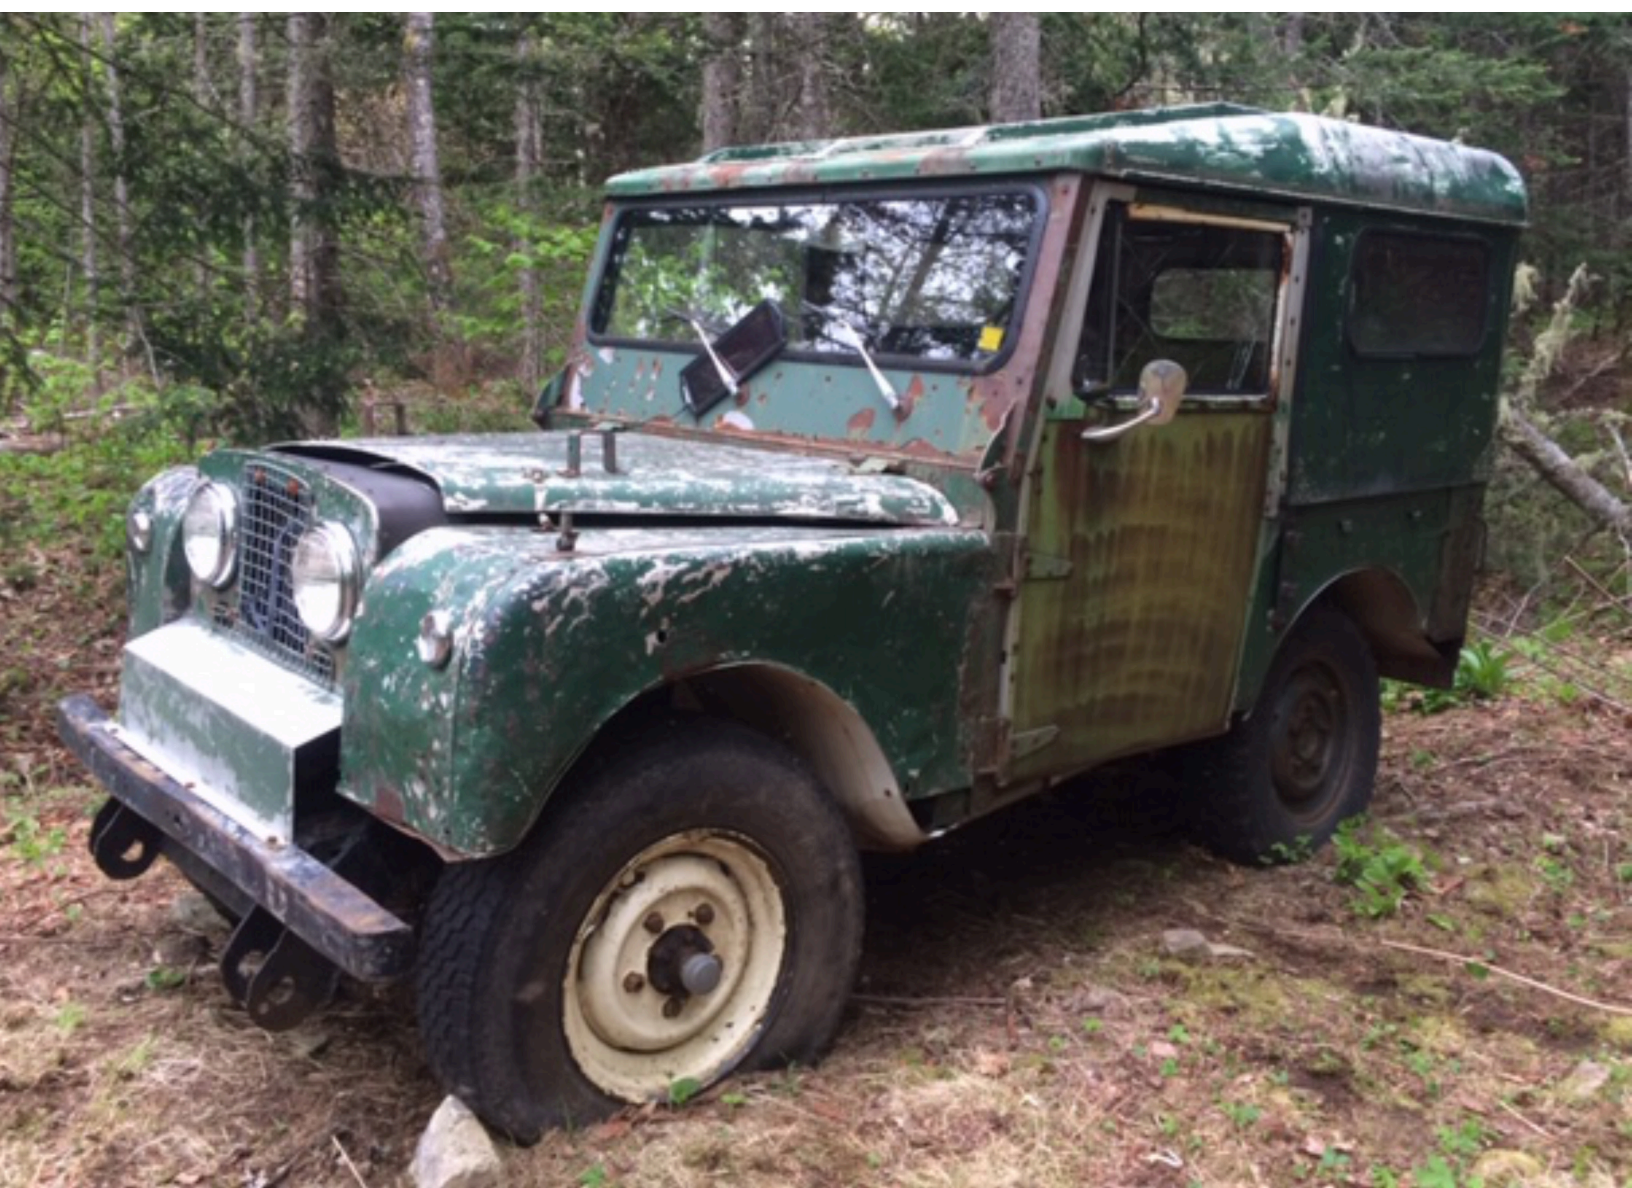
In May 2016, a "1950" Land-Rover appeared for sale in New Brunswick, Canada. Given the year, could this be one of the eighty-nine 1950 vehicles that came to North America?

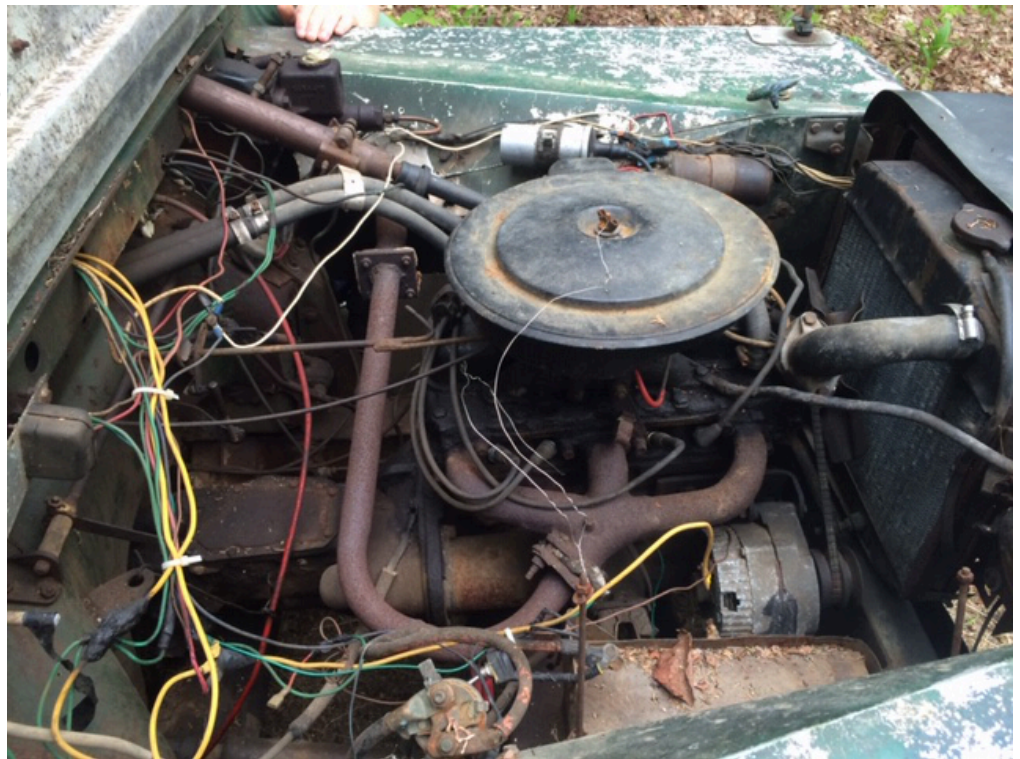
So, what was found: When the engine died, it was replaced with another British engine. (See photo above, upper right) The engine is Morris/Austin, as is the gearbox. To keep the transfer box in the right place, with the longer gearbox, the entire breakfast (radiator support panel and radiator) was pushed forward. [3] (Note breakfast moved forward in photo above)

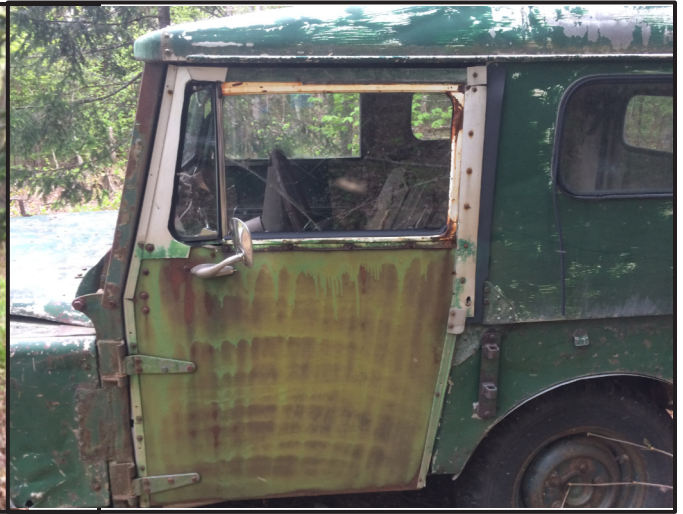
The driver's door was removed (lost?) at some point, and a one-piece replacement was fabricated. (see photo top right of next page) It was noted that this metal and wooden door opened and closed more nicely than any other 80 inch door that John had experience with. This door was also the only smooth panel. In fact, every panel looks like someone took a ball peen hammer to it.

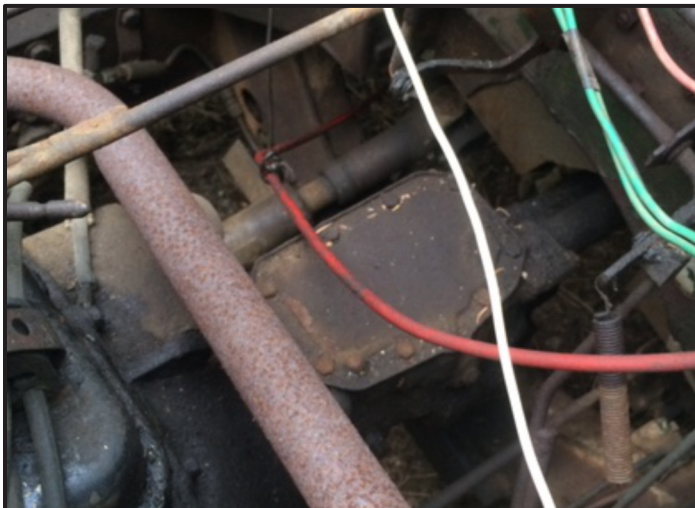
Photo below left, showing the space behind the engine (note exhaust pipe crossing the lower left of the frame) and bulkhead. Lower right, front right photo of 26131666

Note that the motor does not exhaust on the same size as the original 2 litre Rover engine just adds to the innovation. Note how the exhaust exits the manifold, remains level, and wraps behind the engine to exit roughly in the correct spot!
