# General Servicing

## PRS3 Ignition switch By Enrico Agostinelli

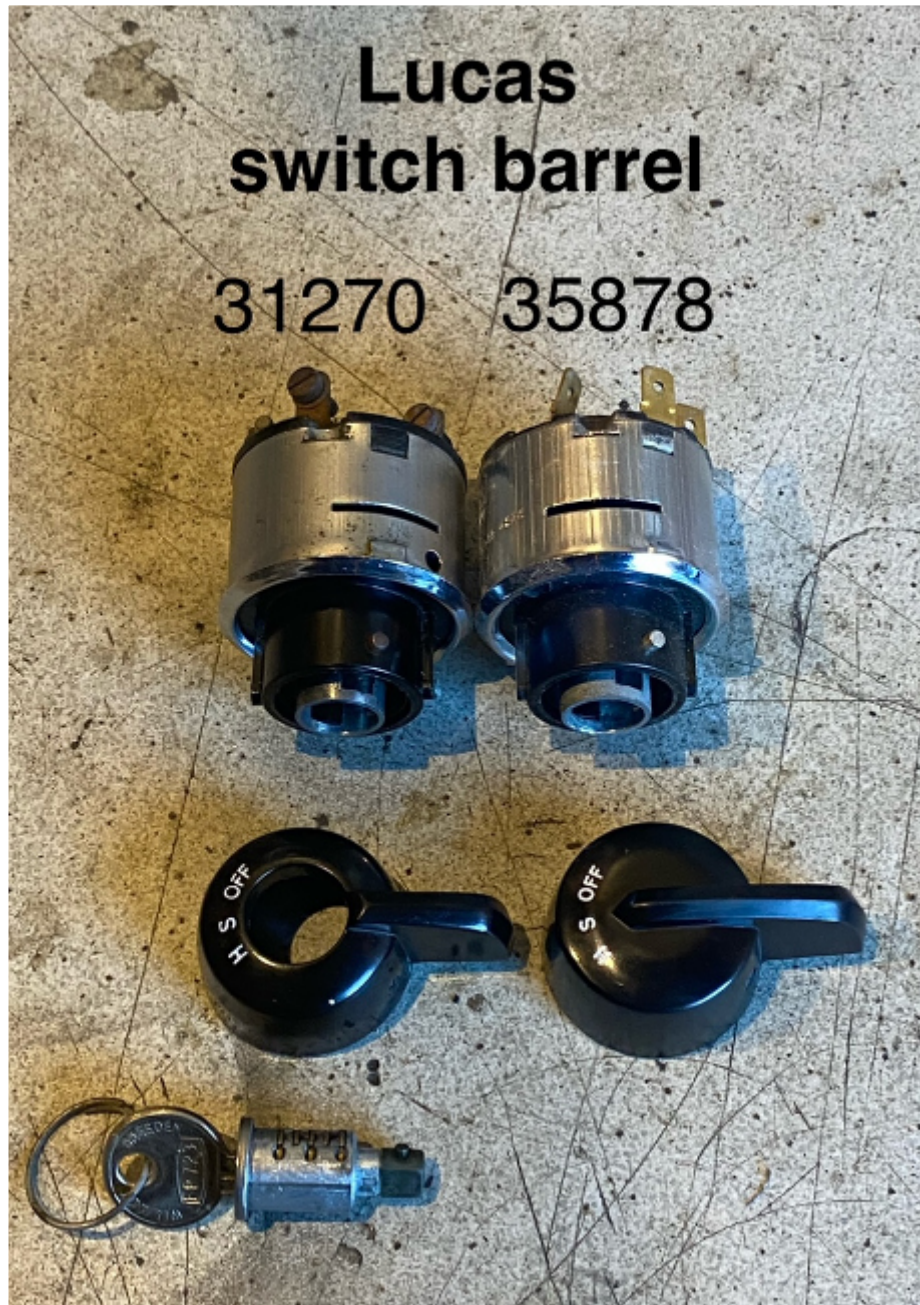
- Lucas 31270 (ignition switch, headlight and sidelight)
- Lucas 35878 (headlight and sidelight switch only, no key for the ignition)  
*See photo to the right*

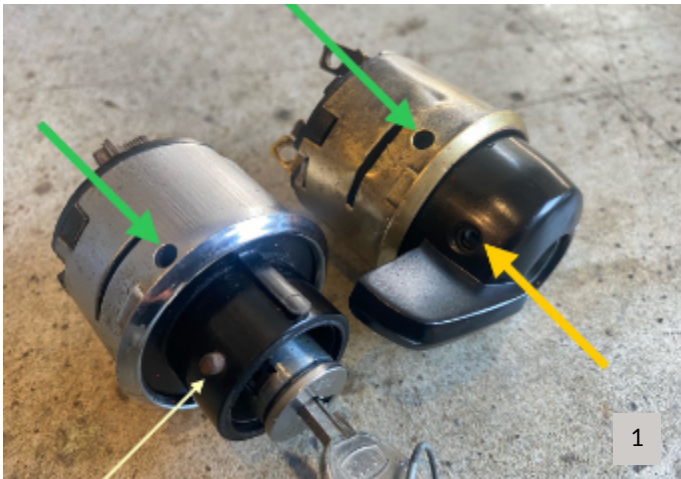
To remove the key barrel, with the key inserted, use the 1/16<sup>th</sup> inch or 2mm bar to insert it in the hole close to the contact plate and press (*photo 1 - green arrow*).

To remove the turning knob, insert the 1/16<sup>th</sup> inch or 2mm bar in the hole on the plastic case (*photo 1 - yellow arrow, top next*

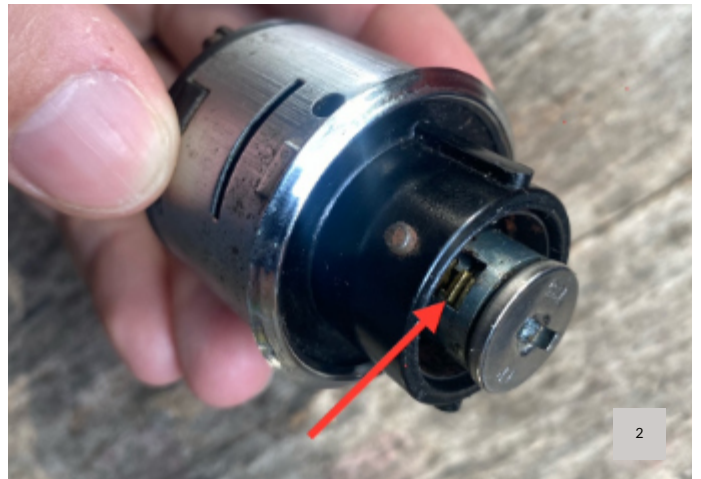
This will release the locking pin in the key barrel. You can now slide it out. [if you have lost the key, you can do the same, but in the barrel you also have to lower each little tab that would go down with the key profile (*photo 2 - red arrow, top next page*).]

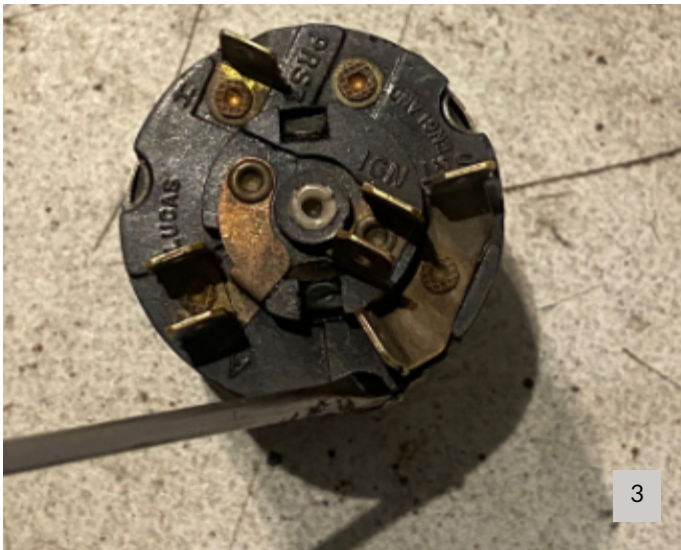
Now on the back, where the contacts are:  
Open the 3 tabs at the back of the case. *Photo 3 above*

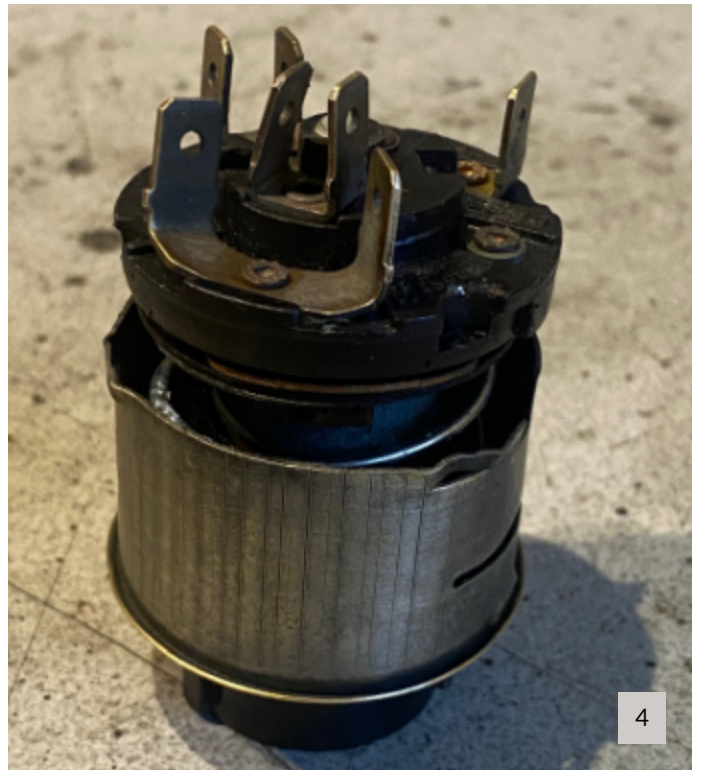
The case is compressed by a large spring, so be careful when you open it. *Photo 4 to the right*

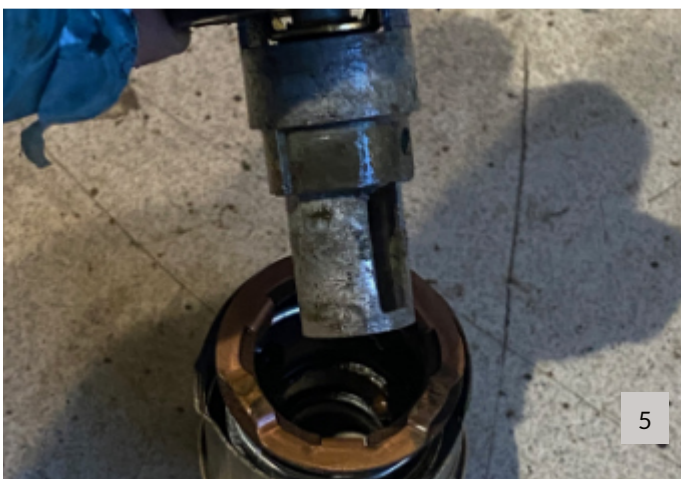
Slide out the plastic/Bakelite plate with the contacts *Photo 5 above*

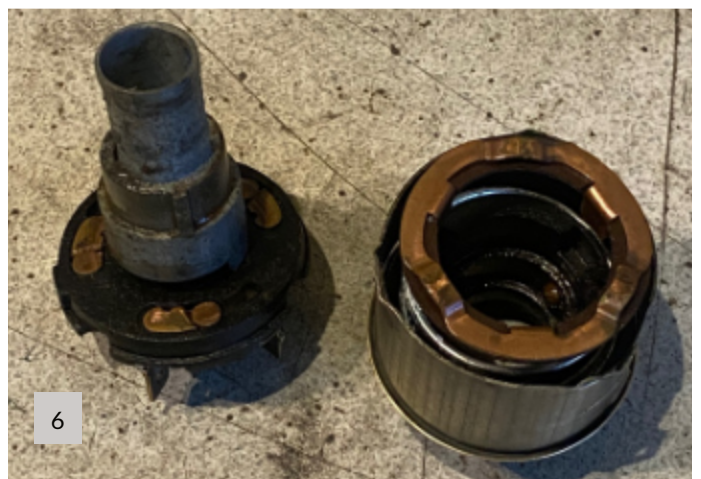
Pulling out the plastic case, also the centre metal tube will come out, be careful at the little sphere that is inside, it's pressed by a little spring. *Photo 6 above*

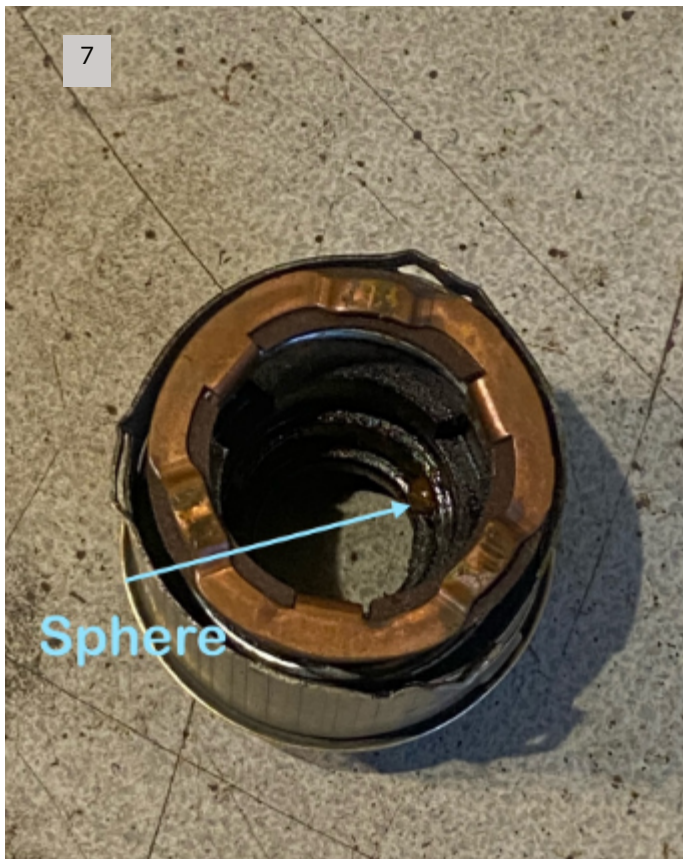
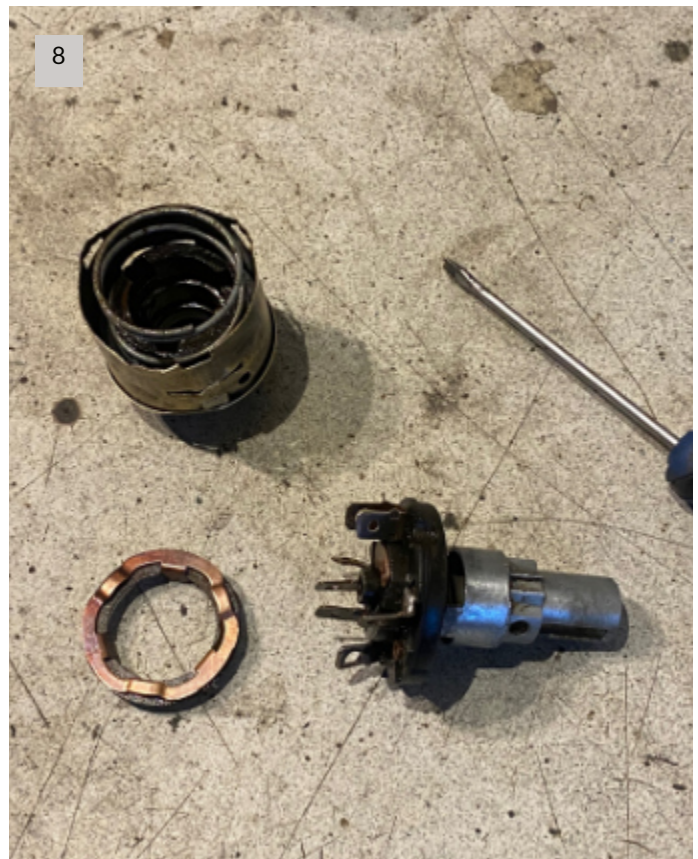
Note ball bearing/ sphere in photo 7 (above left). Photo 8 (above right) is how things should look at this step.

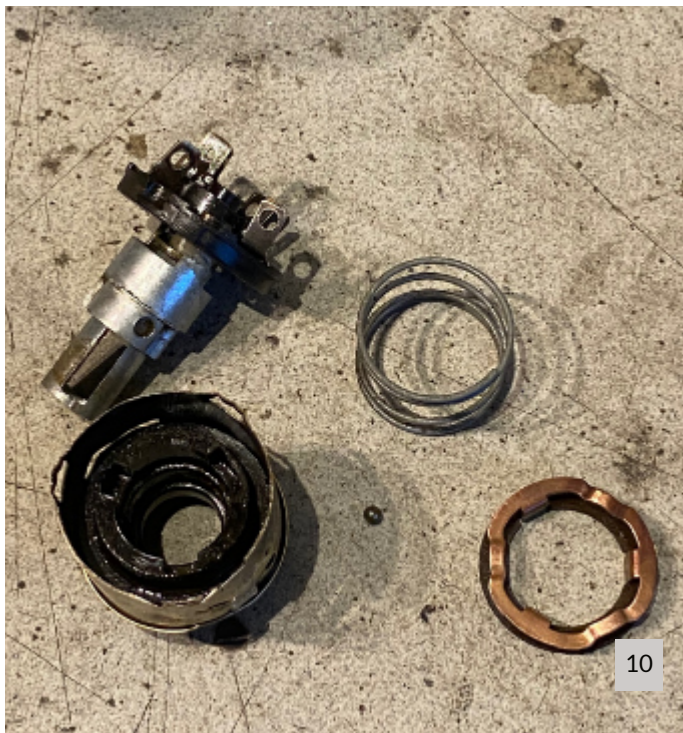
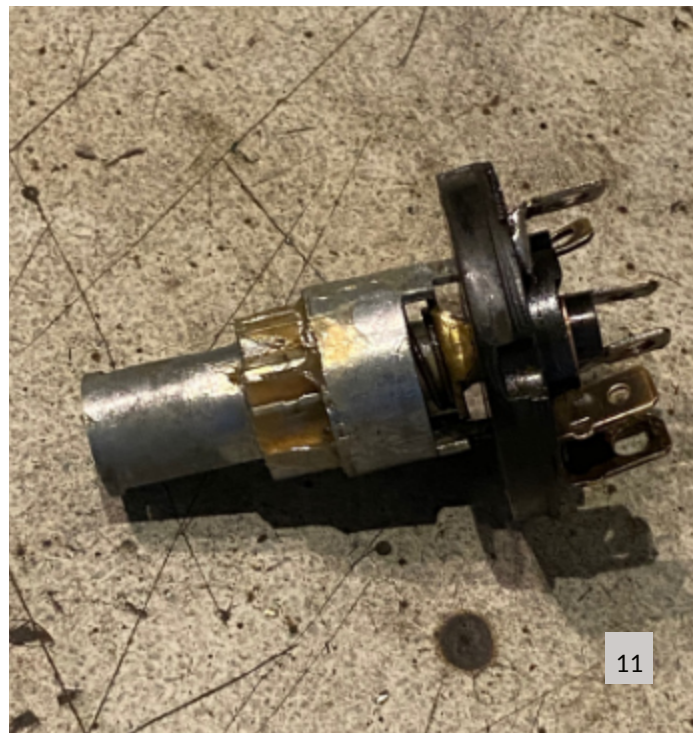
Now you can open everything and clean it and reassemble. Photos 9, 10,11

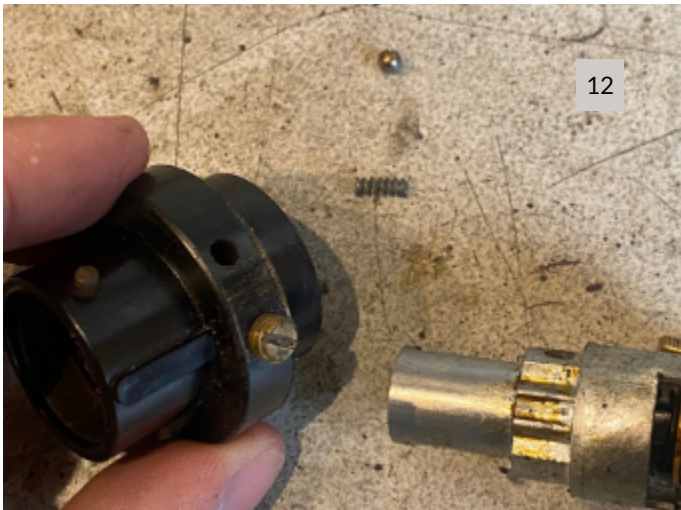
Slide out the inner plastic sleeve (the one that contain the little ball) and you'll see there is a screw on a side. This is used to insert the ball bearing / sphere and spring during the reassembly. I strongly recommend to use grease to facilitate the sphere to stay in place and not falling constantly. *Photo 12 above*

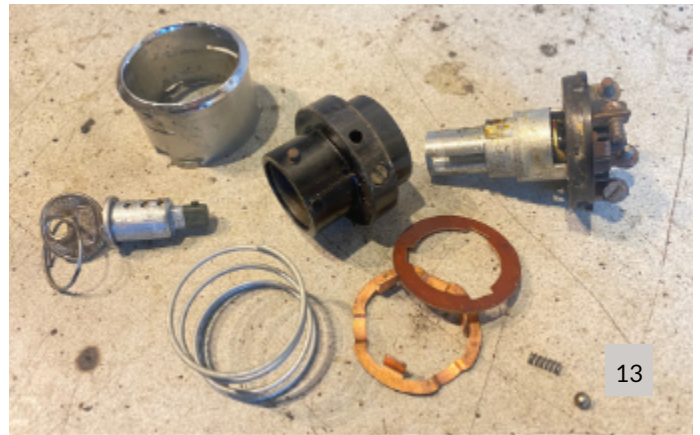
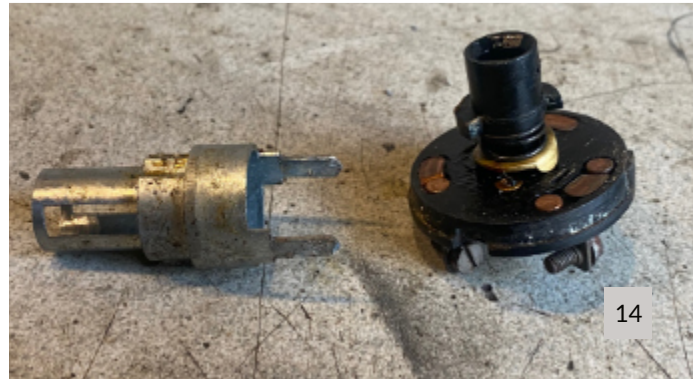
Now you should have the switch fully disassembled *Photos 13 & 14*

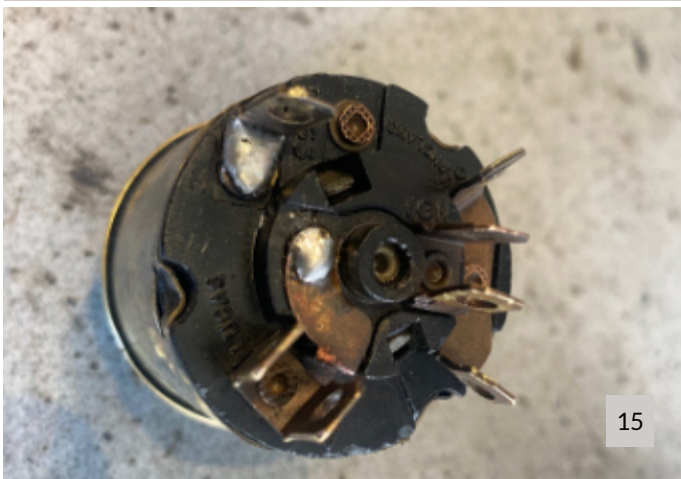
If you have contact problems, now it's time to check every single contact. Check the continuity of every single connection, from the pin to the final tab. Sometimes the problems reside in the "pressed type" contact that connect the connector tabs to the inner contact points. The malfunction can come from an intermittent contact generated by oxidation. I wouldn't recommend disassembling those since parts are not available to replace them; so you can use a little Dremel brass brush to clean the contacts and then solder the plates together. In this way you guarantee the contact between the two (2) surfaces. *(Photo 15 above)*

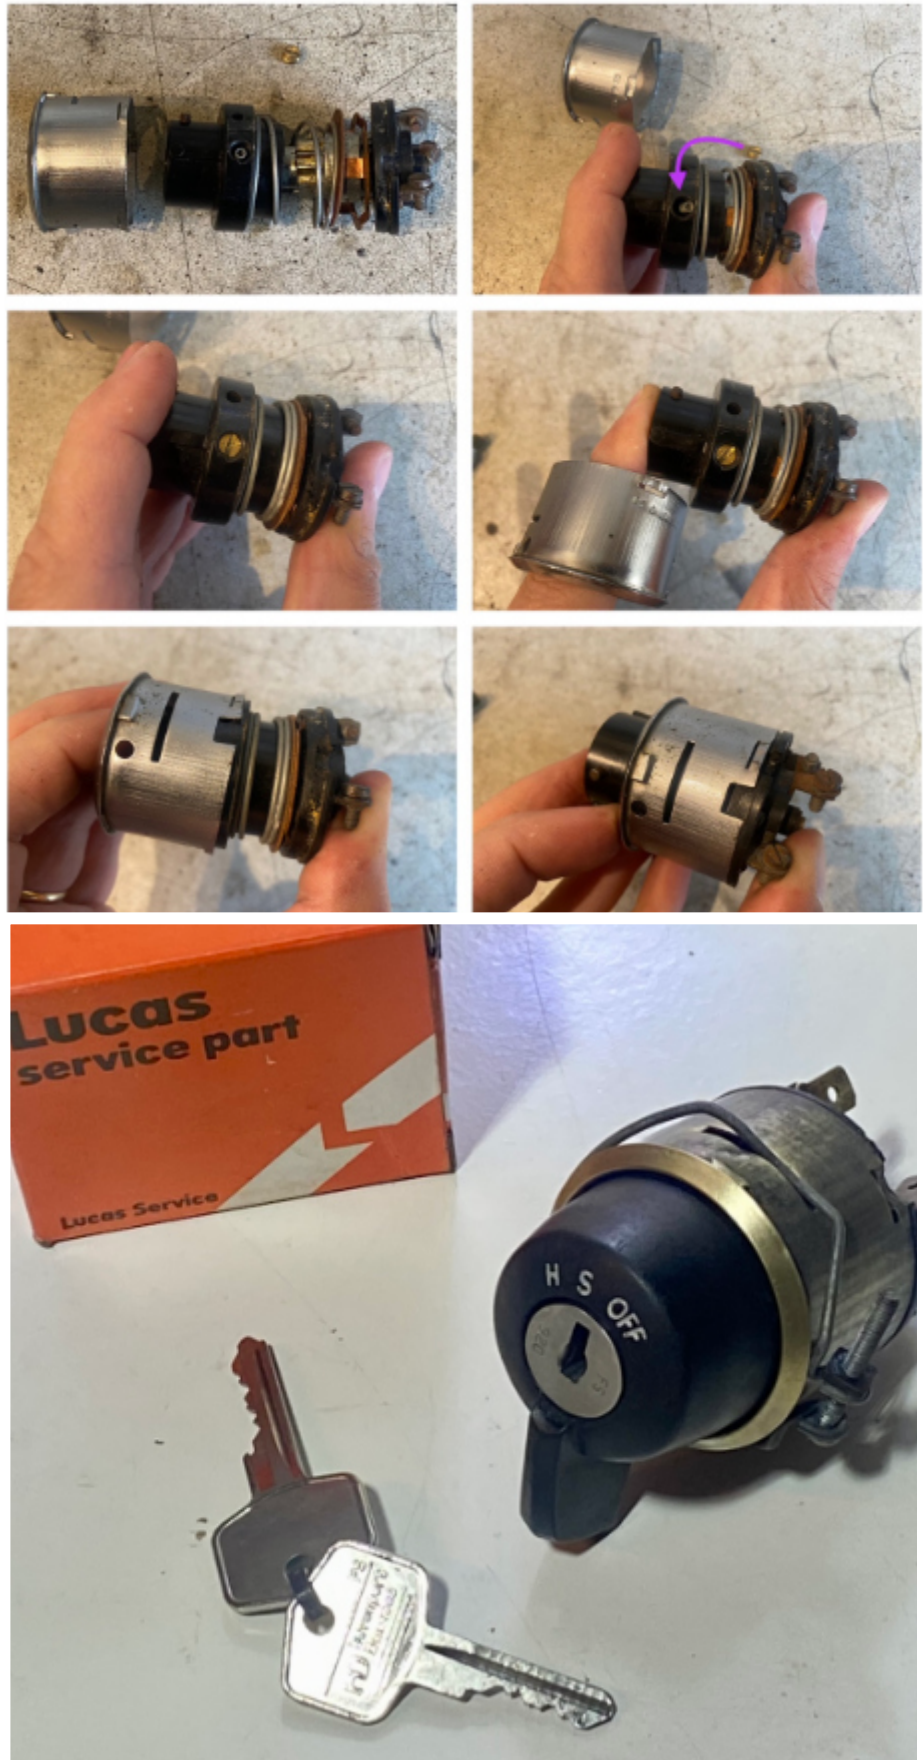
Now it's time to reassemble it. Position all parts in line as per picture, and start the compressing it. The copper ring has 3 tabs that need to be aligned to the plastic sleeve, take your time to align it without forcing too much. The spring doesn't require too much force to be compressed, but if you need help perform this operation in 2. *(Series of photos to the right)*

The back plate has only one position to go in, so check that the plastic tab align to the recess in the metal case. To secure everything, you can now compress the 3 small strip on the metal case to lock it in position.
