Tex magna indicator switch restoration

By Enrico Agostinelli

28 General Servicing Ottawa Valley Land Rovers

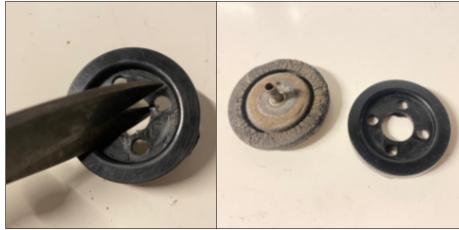
Cut new freewheel. Some come pre-cut, others do not

New rubber insert beside the old existing one.

Cut, or chip out the old rubber wheel. You will find it is quite hardened and comes in pieces

The metal rim, minus the old rubber, The new just stretches on, lining up holes with rivets

Replacing the rubber wheel can be a bit tricky; there are 2 methods to do it and I'll try to explain for each the process:

- 1. Remove the old rubber
- 2. Drill out the 4 rivets
- 3. Clean properly the metal parts
- 4. Position the rubber wheel
- 5. Pack the metal parts around the rubber
- 6. Place new rivets and lock them in place

- 1. Remove the old rubber
- 2. Clean properly the space between
- 3. Place 4 cuts at the bottom of the rubber wheel

4. Push the rubber wheel into the metal recess. To do that, Use plenty of alcohol to facilitate the rubber slippage, and don't exaggerate with the stretch or you'll brake the rubber ring.

The rubber wheel has a direction, it needs to be placed with the deeper recess towards the metal wheel shaft; use the pictures in this paper to support the identification of the side.

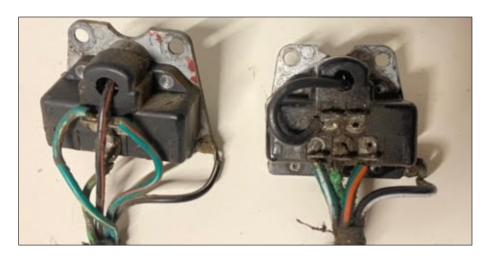
The Switch opened up. Switch connections

The Bakelite switch body is composed by 2 parts, an aluminium base and a Bakelite top. The 2 parts are blocked together by 4 pressed pillars. To open it, drill out the head of the 4 pillars.

Now the content of the switch is exposed; be careful opening it cause the sliding parts are spring loaded on side and top direction. The sliding mechanism is formed by 2 plastic part that slide in the Bakelite recess, and push 2 copper plate that allow the contacts.

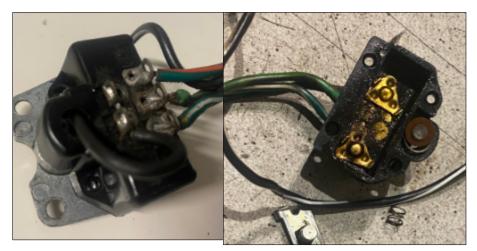
The bakelite switch assembly

The Switch opened up

To check the functionality, clean and check continuity. In some cases there could be shorts circuit that bridge the contacts between the central and side pin.

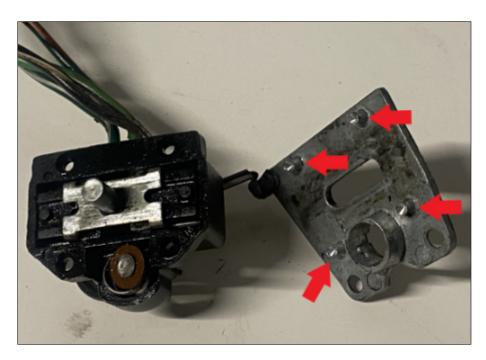
Various places to drill out

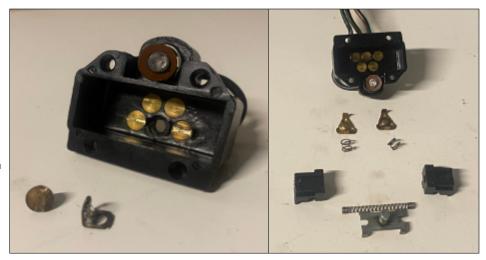
Extreme case damage pin out

The bakelite switch all apart

The resolution differ case by case, so I cannot enter in further detail, but a solder can resolve most of them.

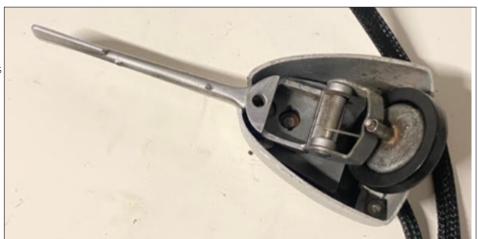
Cleaned and assembled without the bulb

If everything is working, put the Bakelite switch in the body and start the reassembling process. The wheel is the next item to go back, use a drop of oil to make it spin better. The chrome lever goes in and can be held in place by the big screw partially inserted from the bottom.

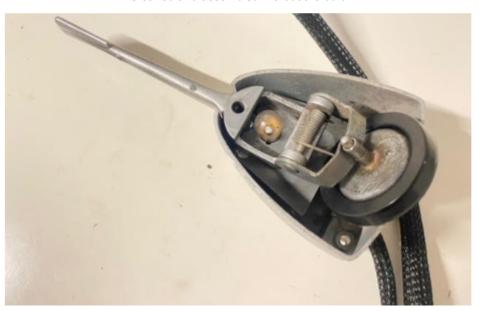
Assembled with bulb

Now the bulb and then finally time to close the body with its top part.
